**Abstract Type : Poster exhibition**

**Abstract Topic : Interventional Nephrology**

## **Kinking of a Peripherally Inserted Central Catheter After Bedside Temporary Hemodialysis Catheter Insertion: A Case Report**

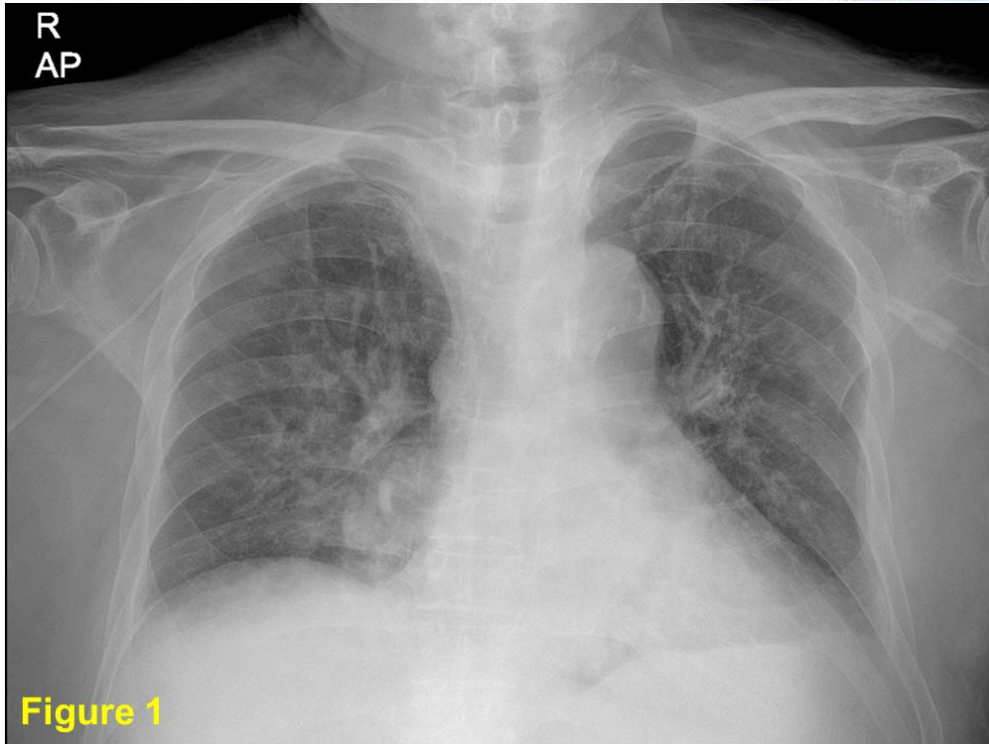
Figure1\_PICC\_Kink\_Case.png

**Case Study :** Background: Insertion of a dialysis catheter is a core procedure of nephrology practice. While urgent dialysis may be life-saving, mechanical and infectious complications related to the insertion of temporary dialysis catheter can be fatal. We report a case in which a peripherally inserted central catheter (PICC) was kinked after bedside temporary hemodialysis catheter insertion in a patient requiring urgent continuous renal replacement therapy. Case: An 84-year-old male patient with end-stage renal disease (ESRD) receiving hemodialysis through a left radio-cephalic arteriovenous fistula was admitted to the orthopedic department for the treatment of lumbar spine spondylolisthesis. During hospitalization, he required intravenous drug administration, for which a PICC was placed via the right basilic vein. (Figure 1) The patient subsequently developed pneumonia and experienced respiratory distress with hypotension, necessitating transfer to the intensive care unit. For emergency continuous renal replacement therapy, a temporary dialysis catheter was inserted into the right internal jugular vein under ultrasound guidance. Following this intervention, malfunction of the PICC line was observed. Chest radiography revealed kinking of the PICC (Figure 2, Arrow), prompting its removal and replacement with a new PICC line. Conclusion: PICC dysfunction can result from mechanical complications such as kinking, thrombosis, or malposition. In critically ill patients, especially those requiring multiple vascular access devices, the risk of catheter malfunction increases. This case underscores the importance of regular monitoring of catheter function, appropriate imaging to assess placement and integrity, and timely intervention to prevent complications related to intravenous access.
